# Manhole Inspection Summary

## Manhole # S17AA1012MH

**Location** Address: **GREENSPRING AVE**

Cross Street: **DRUID PARK DR**

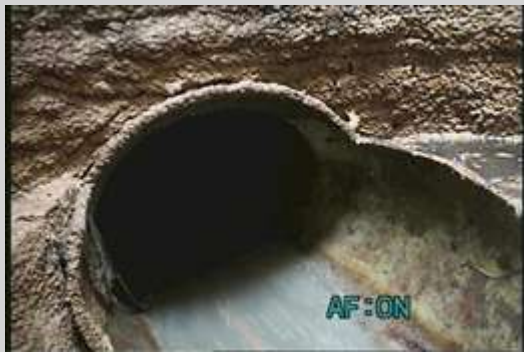
### 15 in. Circular Gravity Sewer Pipe Out @ 12 O'Clock

Pipe Material: **Unknown** ☒ Pipe Lined

Invert Depth: **9.11** (ft.) Flow Characteristics: **Fast**

Infiltration: **None** Pipe Seal Cond: **Unknown**

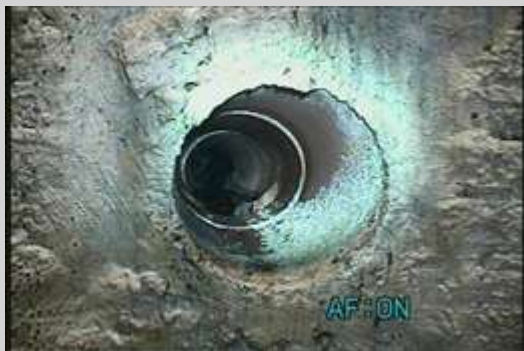
### 10 in. Circular Gravity Sewer Pipe In @ 3 O'Clock

Pipe Material: **Clay** ☐ Pipe Lined

Invert Depth: **6.50** (ft.) Flow Characteristics: **Slow**

Infiltration: **None** Pipe Seal Cond: **Unknown**

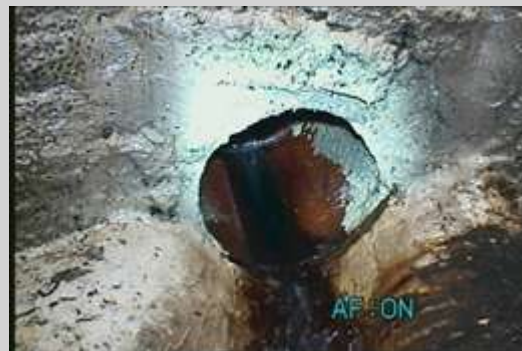
### Drop In @ 3 O'Clock

Drop: **Outside** Rod and Bar

Angled: **Yes** Reading: **7.49** (ft.)

Inv Depth: **8.49** (ft.)

Drop Condition: **Open**

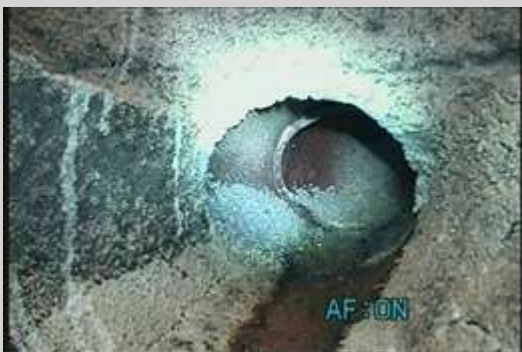
Pipe In @ 9 O'Clock

Pipe Material: **Clay** ☐ Pipe Lined

Infiltration: **None** Pipe Seal Cond: **Unknown**
